Lookouts In The Southwestern Region

Cultural Resources Management Report No. 8

> USDA Forest Service Southwestern Region

September 1989

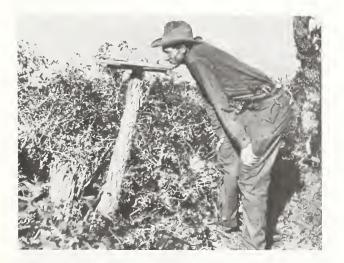
Figure 4. Ranger G. B. Rencher sighting Indian Reservation fire with alidade and protractor from Rose Peak lookout, Apache National Forest, Arizona. C. W. Mckibbin, 1913 (U. S. Forest Service photo, 15238A).

The earliest lookout points were simply convenient mountaintop locations with good visibility which could be visited by fire patrolmen (Figures 2 and 3) on their assigned routes. The first type of fire detection devices constructed at some of these sites was a simple alidade and protractor placed on a tree stump, post or rock so a precise bearing could be obtained (Figures 4 - 8). Judging from photographic evidence, some of these temporary locations were utilized into the early 1930s, and later became the sites of permanent lookout structures.

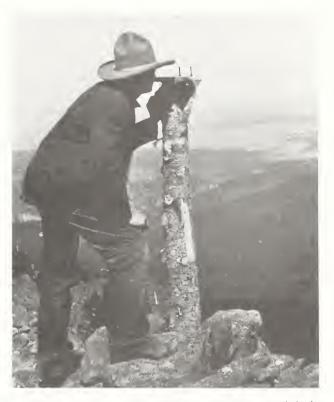
Figure 5. Lookout guard D. W. Edgar sighting fire with alidade and protractor on top of Baldy Mountain (11,200 feet), Apache National Forest, Arizona, 1913 (U. S. Forest Service photo, 15236A).

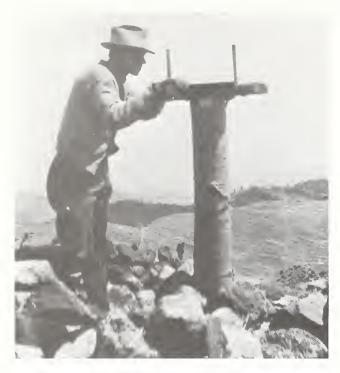
Figure 6. Lookout guard sighting with alidade and protractor, Cibola Forest Reserve, New Mexico, ca. 1910 (U. S. Forest Service photo, 18831A).

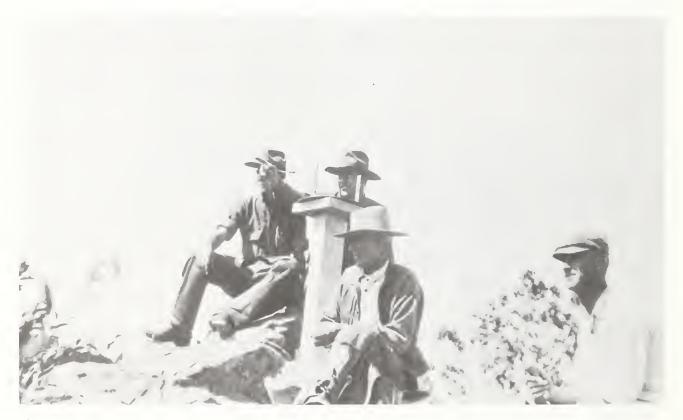
Figure 8. Mount Union lookout, Prescott National Forest, showing the method of installation of a temporary lookout. Photo by J. D. Jones, 1921 (U. S. Forest Service photo, 162953).

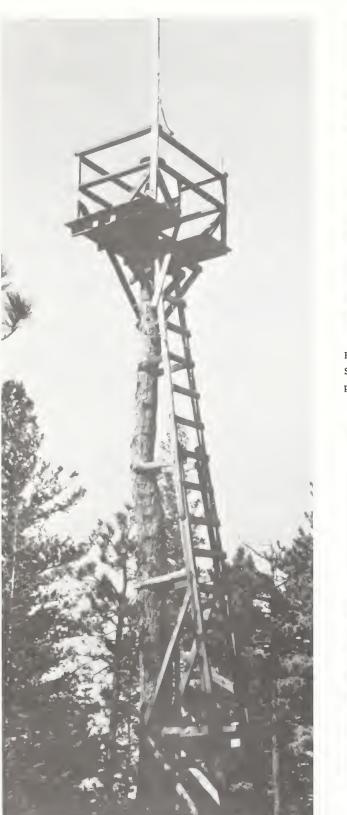
Figure 12. Whites Peak lookout, Carson National Forest, New Mexico in 1947; constructed in early 1920s (U. S. Forest Service photo). Note the elaborate platform for this lookout tree.

At about the same time (ca. 1905 - 1920), lookout trees appear in use. In areas lacking a clear mountain top to set up a protractor and alidade, a lookout tree was utilized. A tall tree was selected that would afford a good view and the top of the tree was modified to support a crude platform. Access was provided by spikes [or lag bolts; hence the term "lag tree"] driven into the side of the tree or by wooden ladders. Usually not permanently manned, lookout trees were probably utilized most commonly by the fire patrolman as he made his rounds of the district.

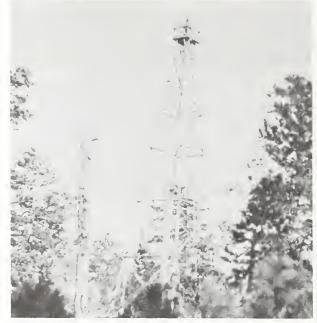
Figure 13. Promontory Butte lookout tower, Sitgreaves National Forest (U. S. Forest Service photo 16471A by C. H. Kissam, 1913).

Figure 47. Promontory lookout, an Aermotor LS-40 with a 120 feet high tower, on Sitgreaves National Forest, Arizona. It was constructed in 1924 to replace the wooden tower in Figures 13 and 14. Photograph made by F. L. Kirby in 1934 (U. S. Forest Service photo 288837).

Located on the Chevelon Ranger District, this 110 feet high Aermotor LS-40 steel tower has a 7 feet square steel cab. It was erected in 1924 to replace a 110 feet high wooden platform built in 1913 (see Figure 13). The associated cabin and storage shed were also built in the early 1920s. When this tower was built in 1924, it was the highest in the country.

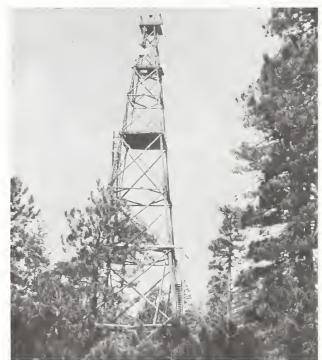
Figure 14. Promontory Butte lookout tower in 1925, Sitgreaves National Forest, Arizona (U. S. Forest Service photo 16225 by Quincy Randles). Note that by this time the old straight up-the-side ladder had been replaced with a stairway type.

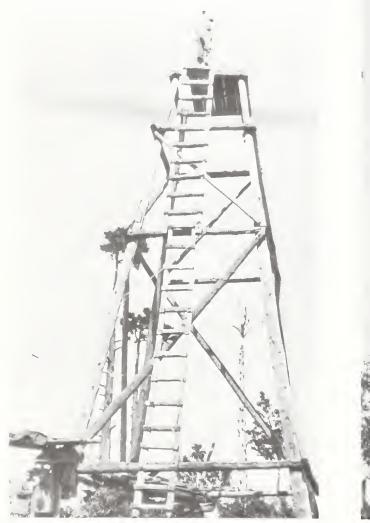
Figure 17. Old Sentinel tower, 1919, Chiricahua Division (now part of Coronado National Forest, Arizona). U. S. Forest Service photo, 235733. Notice the telephone box in the foreground.

It is of interest to note that in a 1919 photograph (Figure 17) of the Sentinel Lookout

Tower on the Chiricahua National Forest (now part of the Coronado National Forest) a telephone box can be clearly seen. Most fire guards stationed at a lookout in the early years of the Forest Service had to ride to a fire and extinguish it themselves or ride for help back to the ranger The need for better communication station. became an early focus on Forest Service research efforts (Gray 1982). The need to detect a fire it necessitated quickly report the and development of good field communications.

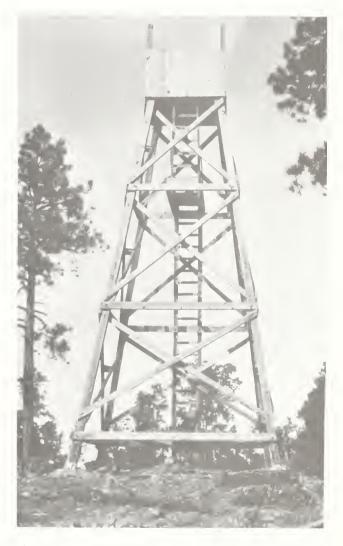
Figure 20. Lookout tower near McGaffey Mill, Cibola National Forest, New Mexico (U.S. Forest Service photo 178064 by J. D. Jones, 1922).

Most of these early wooden towers used an "X" brace construction design, although a few used a "Z" brace design. Most of the platforms on top of the towers were roofless and open on the sides with only a guardrail. A few were enclosed on the sides (Figures 20 - 21) and a few had roofs (Figure 23). The San Antone Lookout in the Carson National Forest in New Mexico, probably constructed in the early 1920s, had a short tower attached directly to a log cabin. This unusual lookout survived into the late 1940s when it was razed by the Forest Service. None of these appear to have had any lightning towers protection.

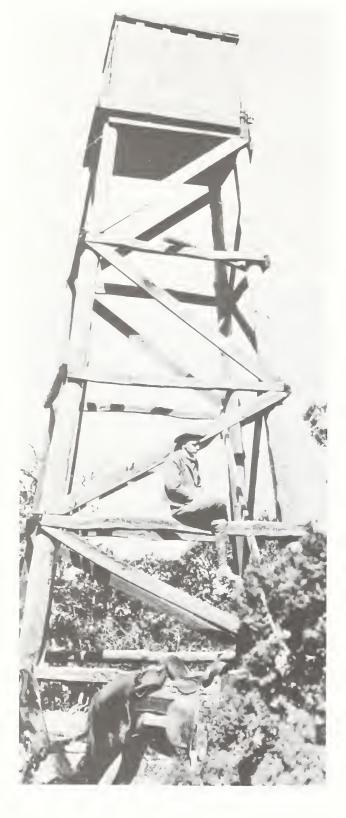
Figure 21. Cedro Peak lookout tower, Cibola National Forest, New Mexico (U.S. Forest Service photo 171232 by K. C. Kartchner, 1922).

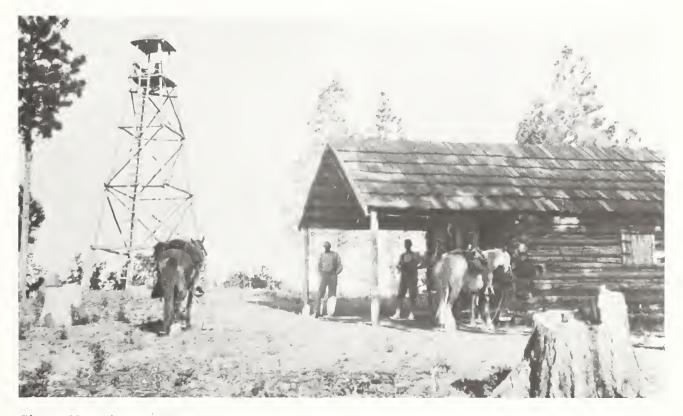
Figure 23. Highland Park lookout tower and cabin, Apache National Forest, (U. S. Forest Service photo 177940 by J. D. Jones, 1923).

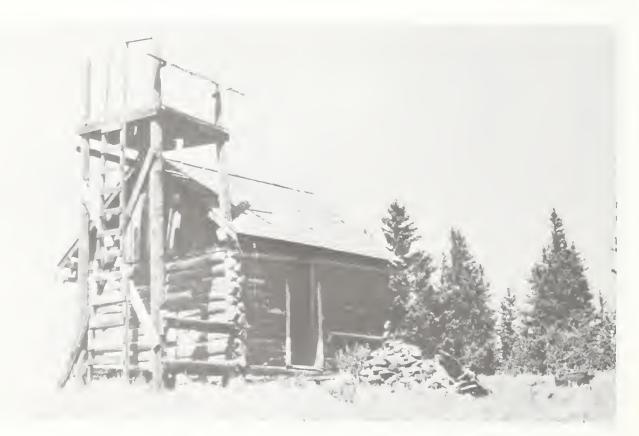
Figure 25. San Antone lookout, Carson National Forest, New Mexico, 1946. This tower was constructed in the early 1920s (U.S. Forest Service photo).

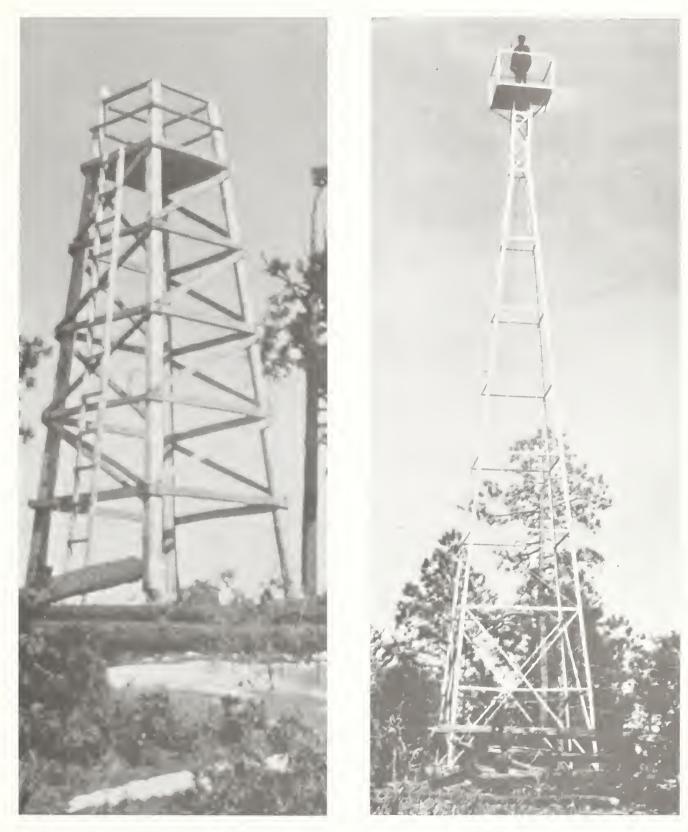
Figure 27. Gila lookout tower on Gila National Forest, New Mexico, ca. 1920 (U.S. Forest Service photo, 17951A).

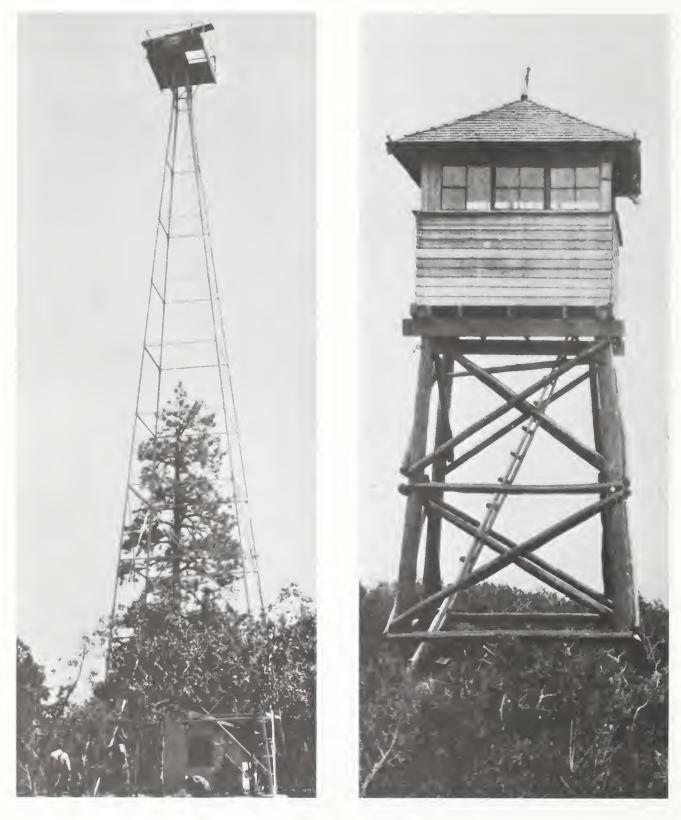
Figure 28. Carrissa lookout tower (steel) on Lincoln National Forest, New Mexico in 1921 (U.S. Forest Service photo 152409 by O. Fred Arthur).

By the early 1920s, some steel observation towers began to appear in the national forests of the Southwestern Region. Figures 28 and 29 show two early examples: one in the Kaibab National Forest in Arizona and the other in the Lincoln National Forest in New Mexico. Historic photographs indicate that although the platforms are different, most of the towers were similar, utilizing an "X" brace support system. These towers may have been manufactured by the Aermotor Company of Chicago, Illinois. An early brochure issued by this company (Aermotor 1903) shows tower designs very similar to the early steel lookout towers illustrated in Figures 28 and 29. It is not known how many of these steel platforms

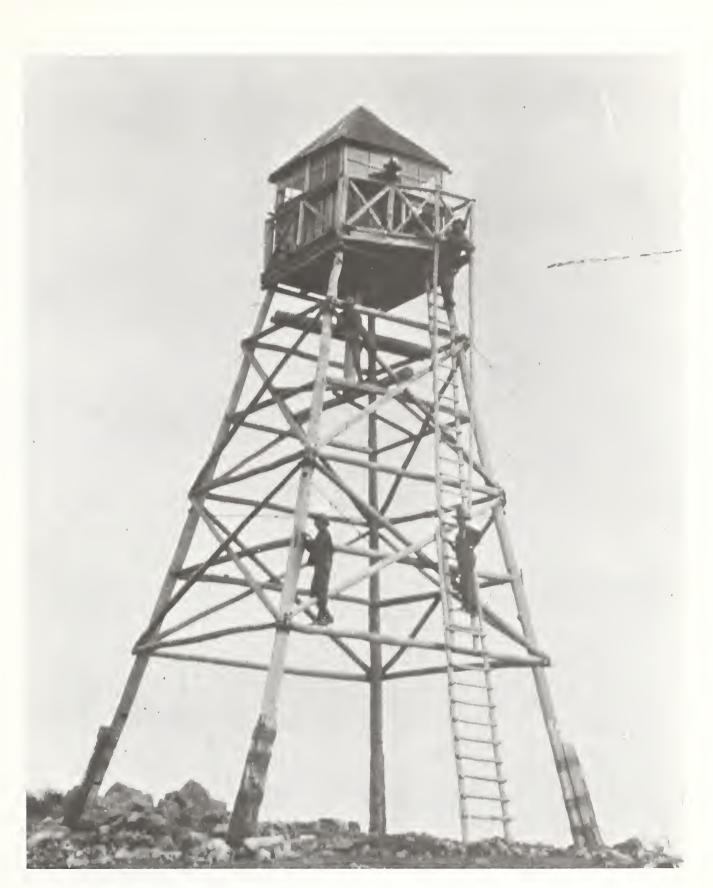
Figure 31. Hillsboro lookout tower on Gila National Forest, New Mexico, in the mid-1920s (U. S. Forest Service photo 210178).

The early wooden live-in lookout towers in the Southwestern Region were modeled to some extent after the duBois design. Early photographs (Figures 30 - 31) show lookouts on the Kaibab and Gila National Forests in the early 1920s that closely resemble the tower cabs in the duBois designs. Figures 32 - 34 show other types of early wooden live-in lookout towers that do not appear to match any of the standardized plans examined. The assumption is that they design plans represented local for which is unavailable. Figure 35 information illustrates a live-in tower constructed in 1932 on Volunteer Mountain in the Kaibab National Forest and probably represents an L-6 design (8 feet by 8 feet) developed in the Northwestern Region (Kresek 1985:11).

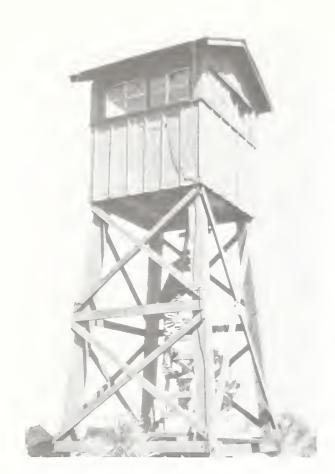
Figure 32. Turkey Butte lookout on Coconino National Forest, Arizona in 1932 (U. S. Forest Service photo 267758 by S. F. Wilson).

The Baker's Butte lookout tower (Figure 36) in the Coconino National Forest, Arizona, closely resembles those shown in Figures 32, 33 and 35, except that it is supported by an "X" brace steel tower.

The history of fire lookouts in the Southwestern Region has been one of type replacements over the years. The early nonstandard towers (Figures 32 - 34) were gradually replaced in many cases by Aermotor Company towers. Figure 41 illustrates an Aermotor MC-24 tower (1925) replacing an old wooden tower in the background.

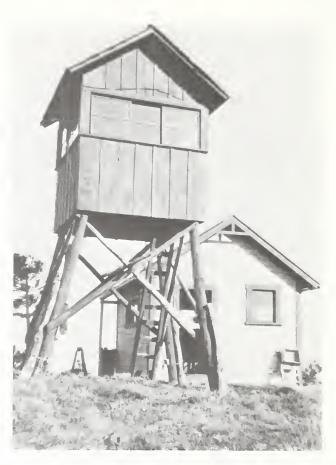
Figure 33. Woody lookout on Coconino National Forest, Arizona in 1932 (U. S. Forest Service photo 267762 by S. F. Wilson).

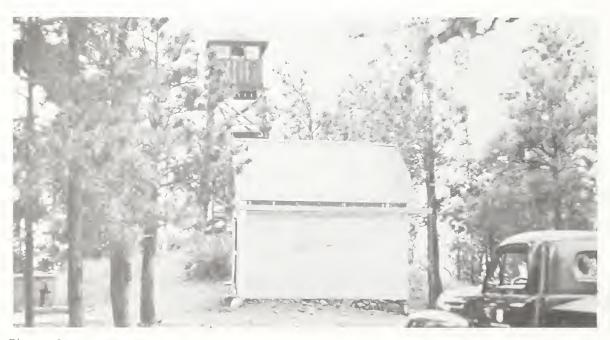
Figure 34. Mt. Sedgewick lookout tower, cabin and cistern, Cibola National Forest, New Mexico, constructed in the 1920s. Photo by R. H. Lewis in 1948. (U. S. Forest Service photo 454118).

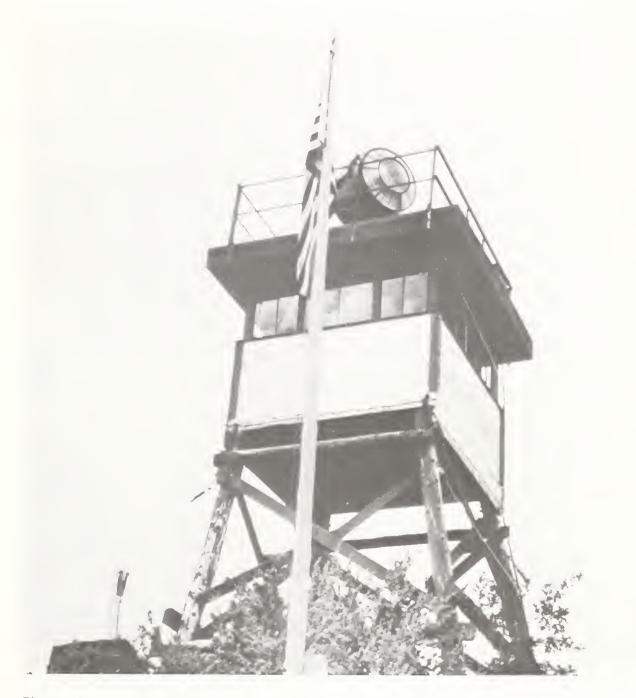
Figure 35. Volunteer Mountain lookout constructed in 1932 on Kaibab National Forest, Arizona. Photo made by R. H. Lewis in 1938 (U.S. Forest Service photo number 399591).

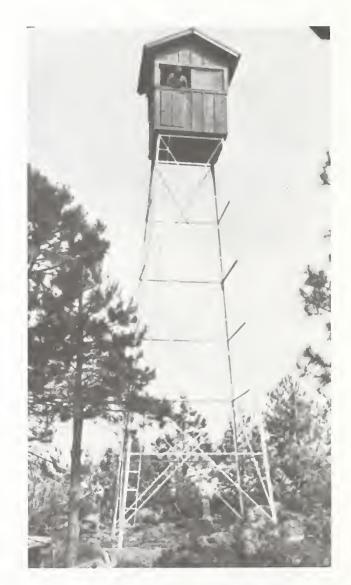
Figure 36. Bakers Butte steel lookout tower, Coconino National Forest, Arizona. Photo by C. N. Lochman, 1921 (U. S. Forest Service photo 162226).

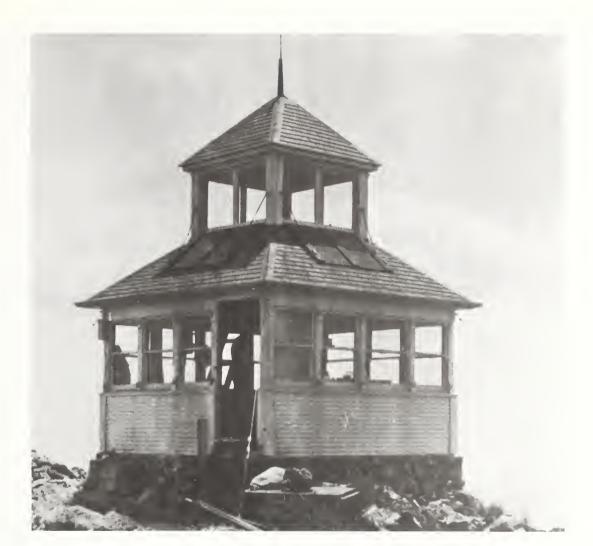
Figure 37. Santa Rita Baldy lookout house, a D-6 cupola on Coronado National Forest, Arizona, constructed in 1927. Photo by S. F. Wilson made in 1929 (U. S. Forest Service photo 235317).

One of the early USFS standard lookout plans was the D-6 cupola designed by Lige Coalman in Oregon. The first D-6 cupola was placed in 1915 on top of Mount Hood outside of Portland, Oregon. The lower part of the frame house measured 12 feet by 12 feet with windows all around and a glassed-in observatory cupola on the roof. Kresek (1985:11) reports that over two hundred D-6s were built on mountain tops in Oregon, Washington, Idaho and Montana. While the D-6 cupola did not become as popular in the Southwestern Region, there were a number of them erected (Figures 37 - 40) on the Coronado, Coconino and Cibola National Forests. Unfortunately, none of these have survived. The D-6 cupola lookout house represented one of the most attractive architectural forms in the variety of fire detection structures. Fortunately, a number of them have survived in the national forests of the Northwest.

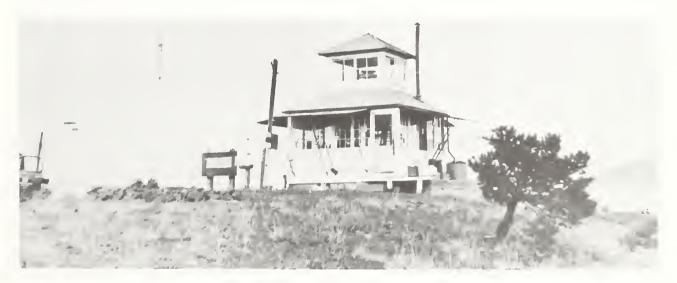
Figure 38. Deadman lookout house, a D-6 cupola, constructed in 1928 on Coconino National Forest, Arizona. Photo by Richard B. Lewis made in 1948 (U.S. Forest Service photo 454127).

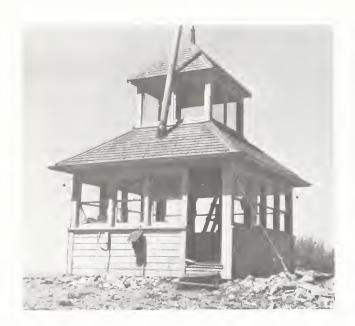
Figure 39. Mt. Withington lookout house, a D-6 cupola constructed on the Cibola National Forest, New Mexico, in 1934. Photo by W. E. Wiltbank made in 1945 (U. S. Forest Service photo 435132).

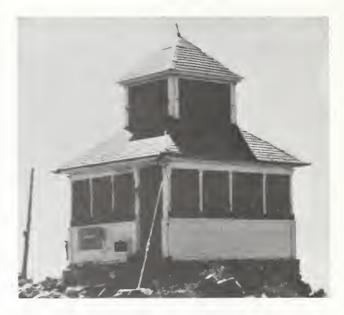
Figure 40. Mt. Wrightson lookout house, a D-6 cupola on Coronado National Forest, Arizona. It was constructed between the late 1920s and early 1930s (U.S. Forest Service photo).

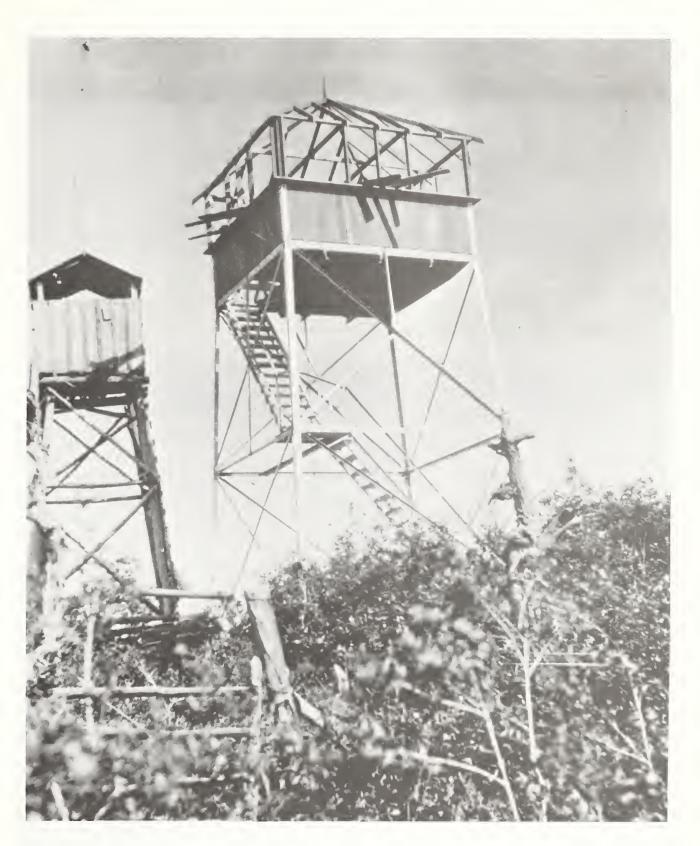
Figure 41. Rose Peak lookout tower, an Aermotor MC-24, under construction with the older wooden tower in the background. The site is on the Gila National Forest, New Mexico. Photo by I. B. Lash in 1928 (U. S. Forest Service photo 233862).

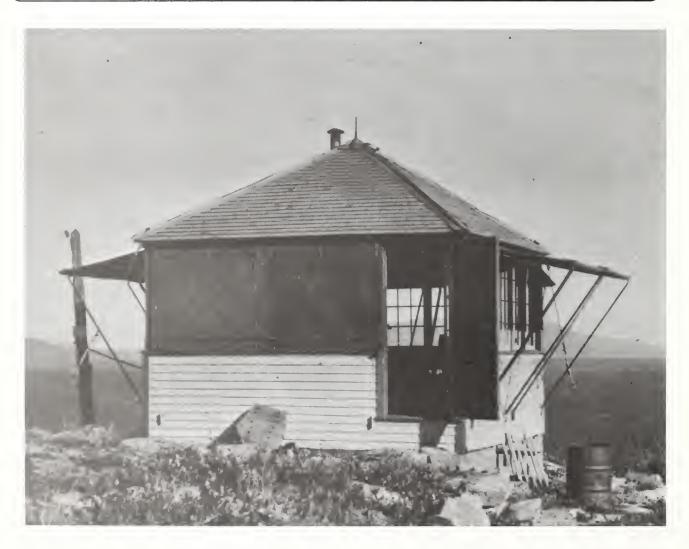
Figure 42. Red Top lookout house, type L-4, in 1946, Santa Fe National Forest, New Mexico. It was constructed in 1933 (U.S. Forest Service photo).

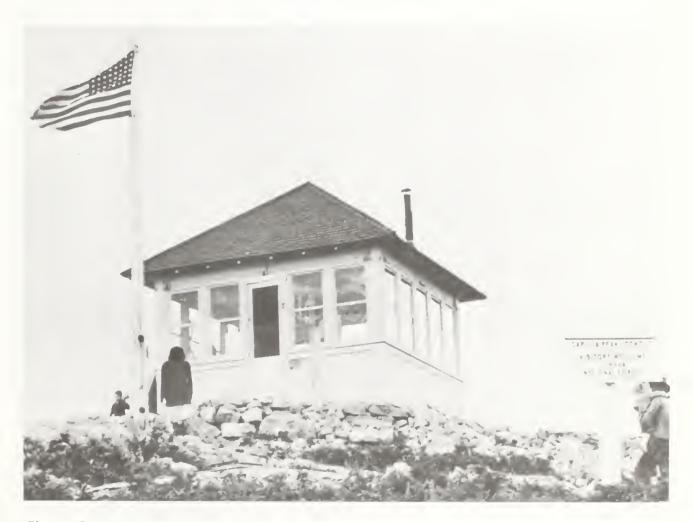
Figure 45. Capilla Peak lookout house (L-4), Cibola National Forest, New Mexico was constructed in 1927. Photograph by W. H. Shaffer, 1939 (U. S. Forest Service photo 383518).

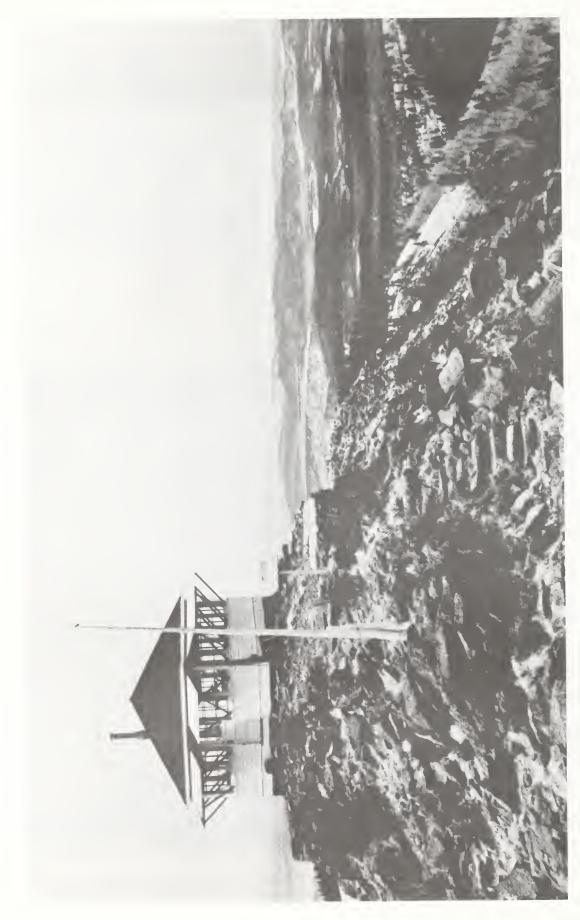
Figure 46. La Mosca lookout house (L-4) on Cibola National Forest, New Mexico. This was constructed in 1940. Photographed by Wayne Winters in 1950 (U. S. Forest Service photo 461601).

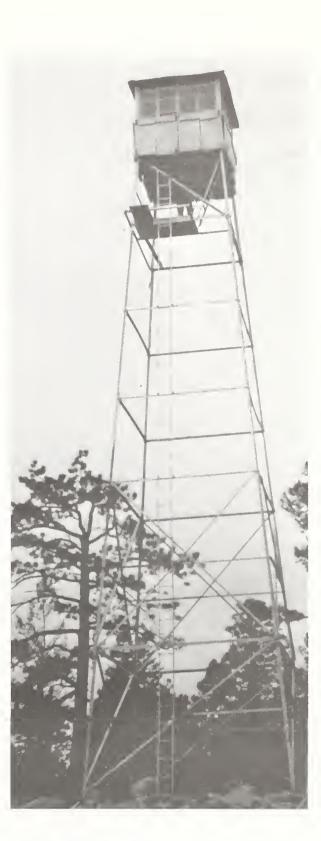
Figure 48. Kiowa lookout tower (an Aermotor type LL-25) located on the Carson National Forest, New Mexico. This lookout was constructed in 1923; the photograph was taken in 1938 (U. S. Forest Service photo).

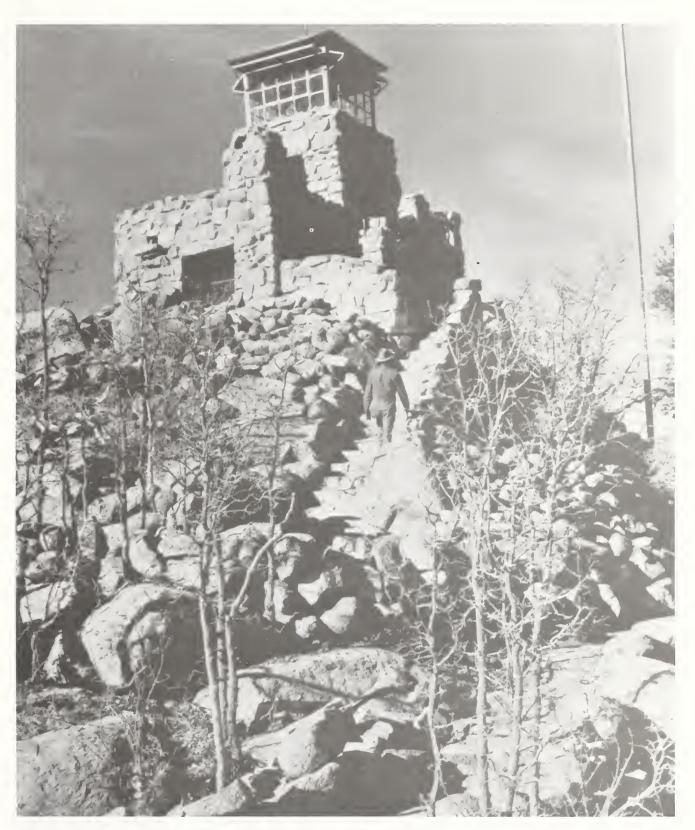
Figure 50. Monjeau lookout, constructed in 1940 on the Lincoln National Forest, New Mexico. This is perhaps the most unique lookout in the Southwestern Region. It combines a metal cab manufactured by International Derrick with a tower of native stone. It is the only example of a "rustic style" lookout in the Region. Photo by W. J. Mead made in 1941 (U. S. Forest Service 413954).

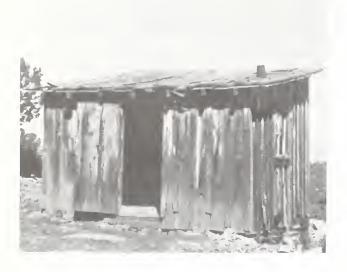
Figure 51. Diamond Point lookout cabin, Tonto National Forest, Arizona in 1937. This was constructed during the early 1920s (U.S. Forest Service, 354456).

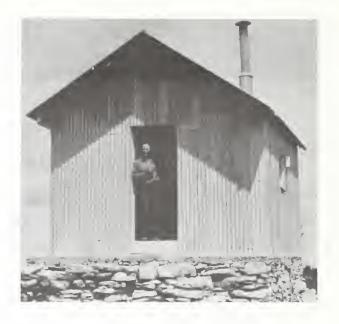
Figure 53. Boiler Peak lookout cabin, Gila National Forest, Arizona, 1946 (U. S. Forest Service photo).

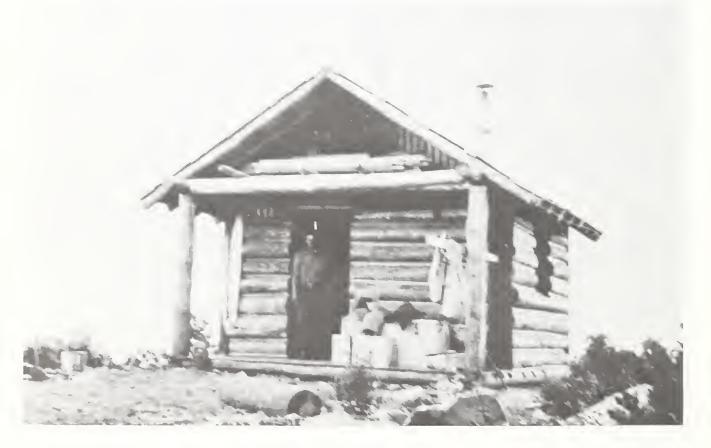
Figure 52. St. Peters Dome lookout cabin on Santa Fe National Forest, New Mexico, photographed in 1932 (U. S. Forest Service photo 270384).

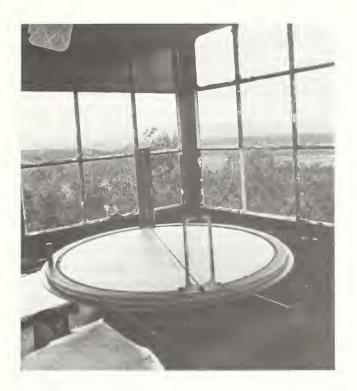
Figure 71. An Osborne fire-finder installed at PS Knoll lookout on the Apache-Sitgreaves National Forests.

In 1911, William B. Osborne, an engineer working on the Mt. Hood National Forest, developed the fire-finding instrument that was to bear his name and become a standard piece of equipment on almost all Forest Service lookouts. Similar to an engineer's transit, it was a high-precision instrument with accuracy to one-sixtieth of a degree. Many other fire-finders would appear over the years: the Koch Board, the Minnesota in 1949, the Wisconsin Conservation Department's, the Kentucky, and the Arkansas (Kresek 1985:29). All would be short-lived. The Osborne, scaled down in size in 1934, became the standard for all lookouts. It was first used on the Larch Mountain lookout, Mount Hood National Forest in 1914. Figures 71 and 72 show examples of the Osborne fire-finder.

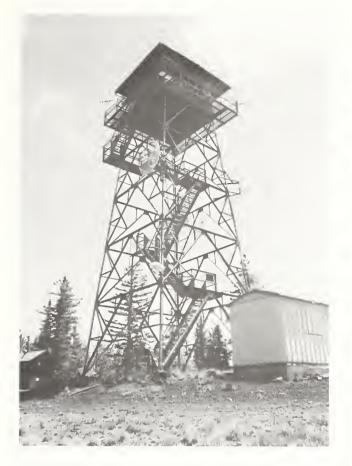
Located on the Springerville Ranger District, this 54 feet high steel tower has a 14 feet square steel cab (Figure 73). It was constructed in 1962, replacing an earlier Aermotor MC-24 previously erected in 1933. The present lookout represents a USDA - Forest Service standard plan CL-100 to CL-106 series, also known as an R-6 flat. The tower is not recommended for National Register eligibility since its construction date is too recent (less than 50 years old), it does not represent an exceptional type and its site integrity has been compromised by the intrusion of microwave towers.

Figure 73. Greens Peak lookout (CL-100 series) on the Apache-Sitgreaves National Forests.

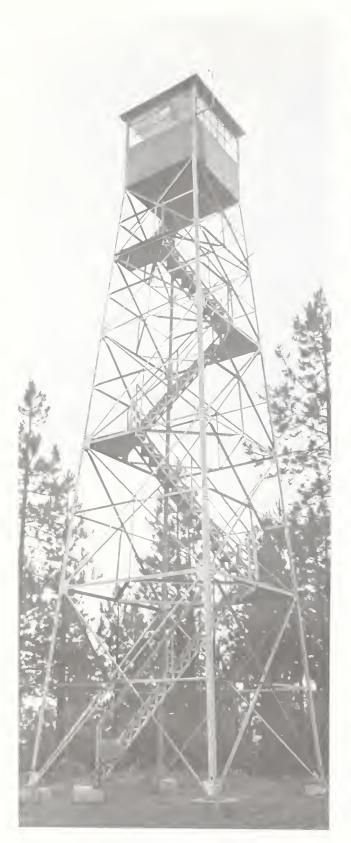
Figure 75. PS Knoll lookout built by the CCC in 1939 on the Apache-Sitgreaves National Forests. This is an Aermotor MC-40 type and is 45 feet tall. The view is looking to the south east.

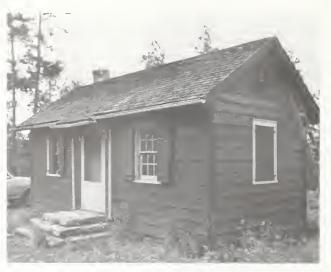
Figure 76. PS Knoll lookout cabin built in 1939. This view is to the northwest.

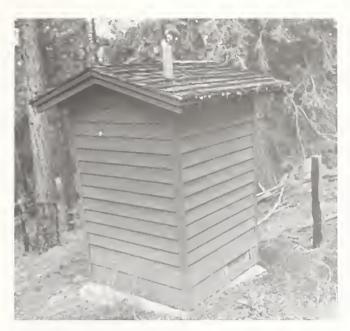
Figure 79. This privy at PS knoll lookout was built in 1940 to a standard plan.

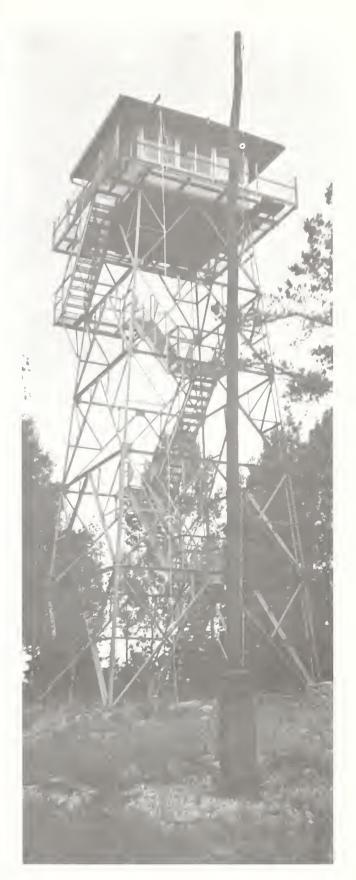
Located on the Alpine Ranger District, this USDA Forest Service, CL-100 to CL-106 type, 54 ft steel tower has a 14 ft by 14 ft steel cab (Figure 80). The lookout was constructed in 1965, replacing an earlier LX-25 Aermotor tower. The privy (Plan U-10) was constructed in 1965. Since this lookout was constructed less than 50 years ago and does not represent an exceptional type, it is not recommended for National Register eligibility.

Figure 80. Reno lookout, Apache-Sitgreaves National Forests (CL-100 series).

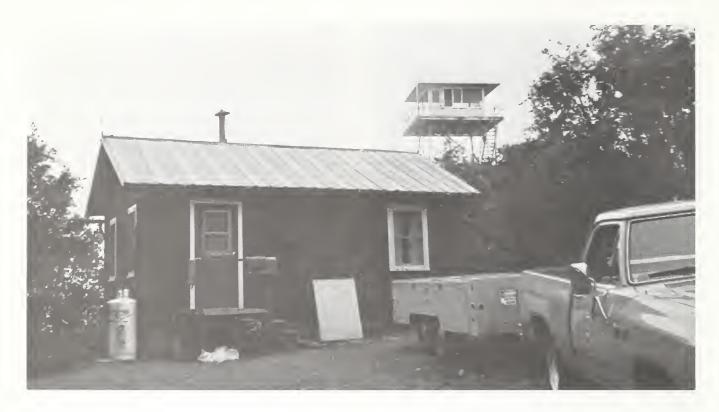
Located on the Clifton Ranger District, this Aermotor MC-24 type lookout is 30 feet high and had a wood cab 12 feet square. Constructed in 1929 to replace several earlier wooden platform towers, Rose Peak lookout underwent major

structural alternations in 1981. The original MC-24 cab was replaced by a larger 14 feet square cab and the stairs were rebuilt (Figure 81). The dates on the cabin and storage shed are unknown. The privy (Plan U-10) was probably constructed in 1929. The lookout tower, due to the replacement of its original cab, has lost its integrity of construction, design, materials and workmanship and is not recommended for National Register eligibility.

Figure 81. Rose Peak lookout and cabin on the Apache-Sitgreaves National Forests. The lookout is an Aermotor MC-24 constructed in 1929 and then altered in 1981.

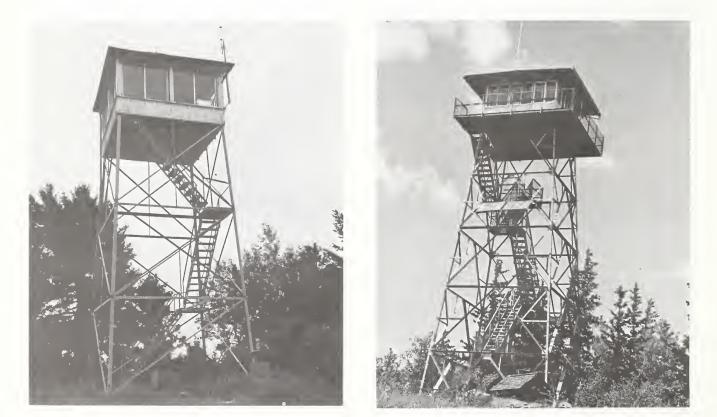
Located on the Alpine District, this 30 feet high MC-24 Aermotor steel tower has a 12 feet square wood cab. It was constructed in 1933, probably by the CCC. This lookout was extensively remodeled in the 1960s. The windows and siding were altered from their original design (Figure 82). The lookout has lost its integrity of construction, design, workmanship and materials and is not recommended for National Register eligibility.

Figure 82. Blue lookout (Aermotor MC-24), on the Apache-Sitgreaves National Forests.

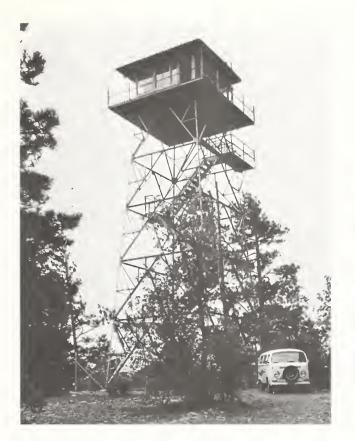
This lookout represents the CL-100 standard plan type and was constructed in 1959. It is a 54 feet high steel tower with a 14 feet square steel cab (Figure 84). The privy was also constructed in 1959. The lookout, less than 50 years old, does not represent an exceptional type and is not recommended for National Register eligibility.

Figure 84. Juniper Ridge lookout, a CL-100 series, Apache-Sitgreaves National Forests.

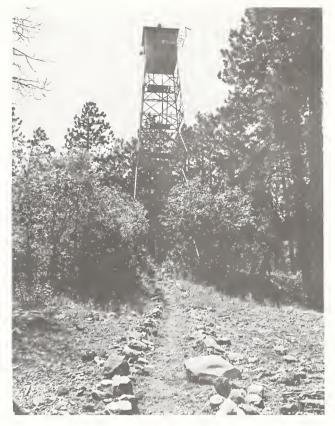
This Aermotor MC-24 steel tower, located on the Alpine Ranger District, was constructed in 1933, probably by the CCC. It is 45 feet 9 inchs high and has a 7 feet square steel cab (Figure 85 -94). The storage shed (an old cabin) was built in 1928. The present cabin and privy were built in 1940. There was an old wooden platform tower

Figure 85. Bear Mountain lookout (Aermotor MC-24) on Apache-Sitgreaves National Forests.

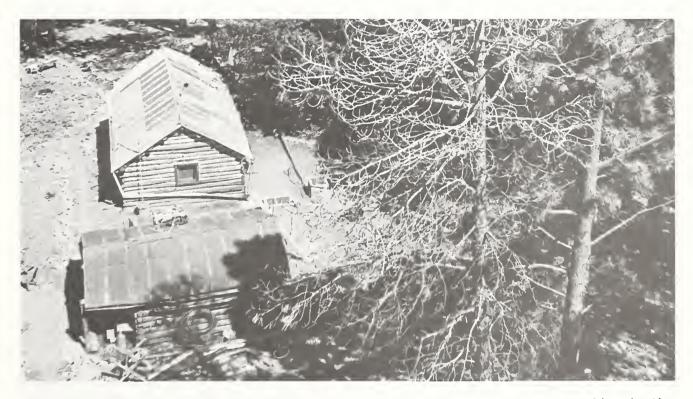
Figure 86. The Bear Mountain lookout cabins viewed from the lookout. The old cabin, in the foreground, was built in 1928 and is now used for storage.

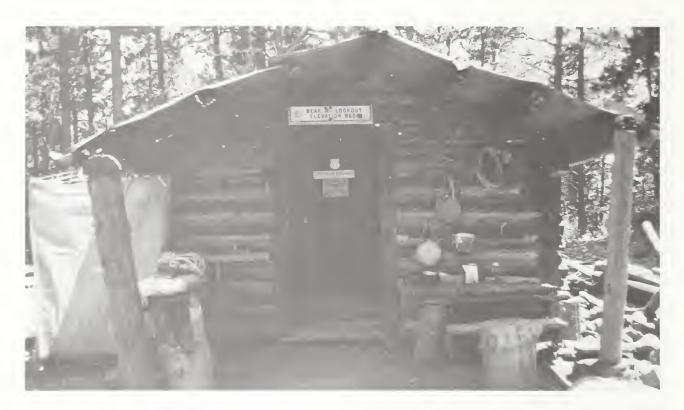
Figure 87. The Bear Mountain lookout storage shed (original cabin), Apache-Sitgreaves National Forests.

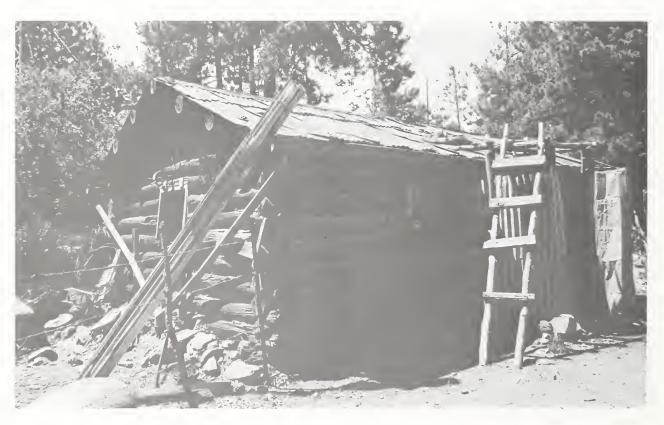
Figure 88. Side view of the Bear Mountain lookout storage shed (original cabin), Apache-Sitgreaves National Forests.

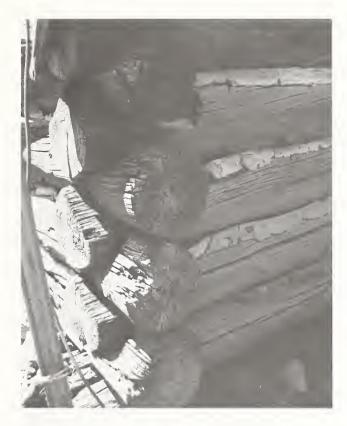
Figure 89. Dovetail corner notching on the Bear Mountain lookout storage shed (original cabin).

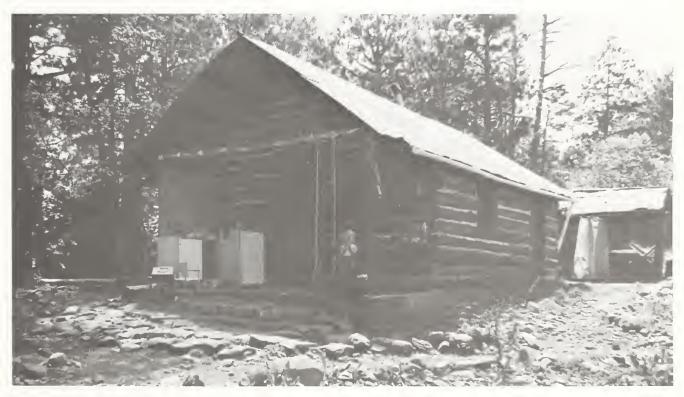
Figure 91. The "new" Bear Mountain lookout cabin, built in 1940.

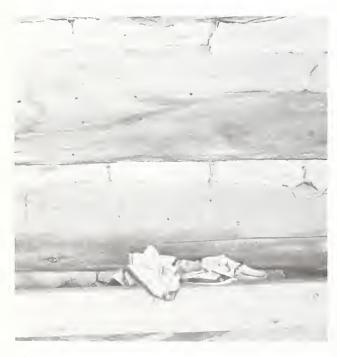
Figure 93. Graffiti on an interior wall showing the date of construction of the Bear Mountain lookout storage shed (original cabin).

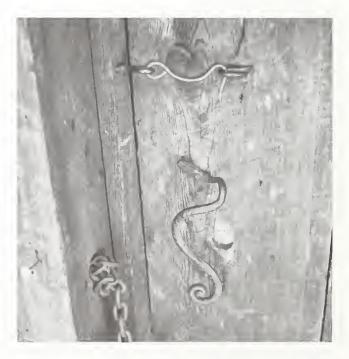
Figure 94. Wrought iron door hardware on the Bear Mountain lookout storage shed (original cabin).

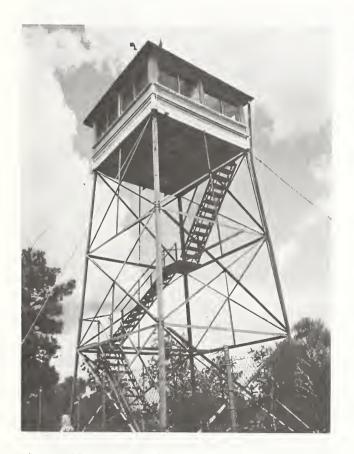
Located on the Lakeside Ranger District, this 30 feet high MC-24 Aermotor steel tower was constructed in 1933, probably by the CCC. It has a 12 feet square wood cab. It underwent extensive remodeling in 1967, when all the original windows were replaced (Figure 95). It has lost its original integrity of design, construction, workmanship and materials and is not recommended for National Register eligibility.

Figure 95. The Springer Mountain lookout, an Aermotor MC-24, located on Apache-Sitgreaves National Forests.

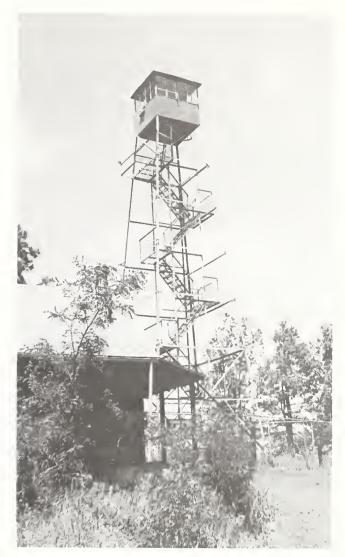
Figure 96. Lake Mountain lookout and cabin, Apache-Sitgreaves National Forests (Aermotor LX-24).

Located on the Lakeside Ranger District, this 48 feet high Aermotor LX-24 steel tower has a 7 feet square steel cab and was constructed in 1926. Study of historic photographs indicates that while the original ladder was replaced in the 1930s, the lookout and its associated cabin (also built in 1926) have retained their original integrity of design, construction, workmanship, materials, setting, location and association. The lookout complex is associated with the Los Burros Ranger Station site, which is already listed on the National Register. The entire lookout complex (Figures 96 - 97) at Lake Mountain is recommended for National Register eligibility.

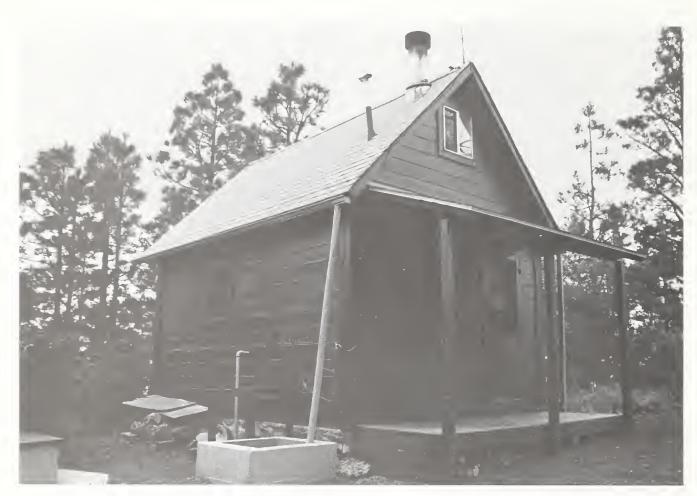
Figure 97. Lake Mountain lookout cabin, built in 1926 on the Apache-Sitgreaves National Forests.

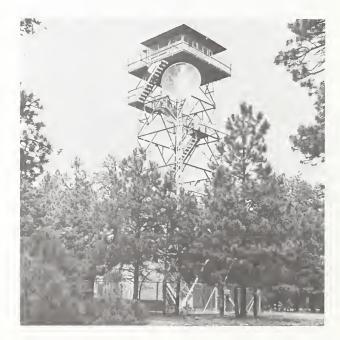
This 67 feet high steel tower is a standard plan CL-100 with a 14 feet square steel cab (Figure 98). It was built in 1965 on the Heber Ranger District. The privy, office and storage shed are all of recent construction. The lookout does not represent an exceptional type, is less then 50 years old and is not recommended for National Register eligibility.

Figure 98. Gentry lookout, a CL-100 type, on Heber Ranger District of the Apache-Sitgreaves.

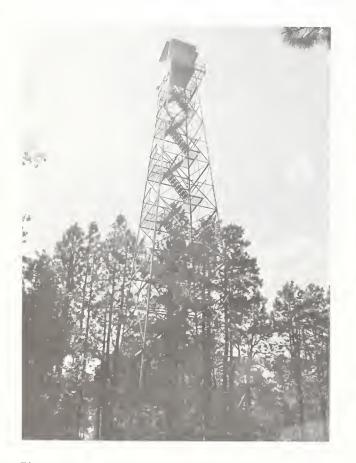
Built in 1966, this 100 ft high Aermotor LS-40 has a 7 ft by 7 ft steel cab (Figure 102) and is located on the Chevelon Ranger District. This tower may represent one of the last Aermotor towers erected in the Southwestern Region as the Aermotor Company went out of business around this time. This tower has retained its integrity of design and construction; however, it is less than

Figure 102. O'Haco lookout, an Aermotor LS-40, on the Apache-Sitgreaves National Forests.

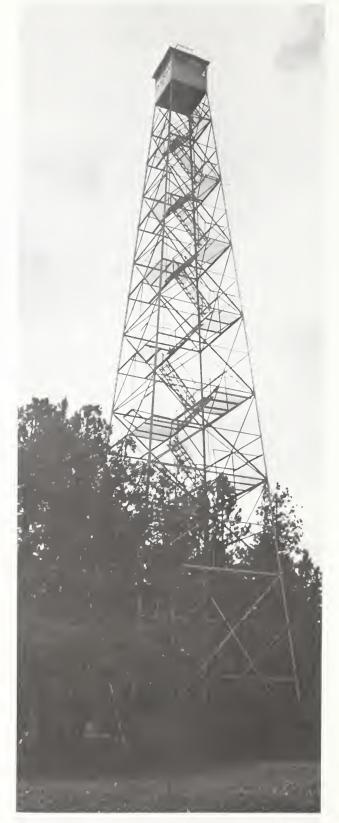
The original ladder was replaced with stairs in 1938. The interior paneling was whitewashed in 1966 and a decorative motif was burned in with local cattle brands. Examination of historic photographs from the 1920s indicates that this lookout and associated cabin have retained their original integrity of design, construction, workmanship, location, setting, association, and materials. The lookout and cabin (Figures 103 -104) and storage shed are recommended for National Register eligibility.

Figure 103. The Promontory Butte lookout, an Aermotor LS-40, Apache-Sitgreaves National Forests.

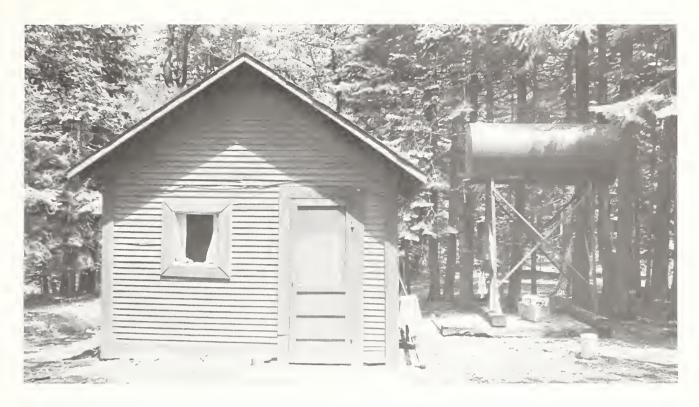
Figure 104. The cabin at Promontory Butte lookout was built in the early 1920s.

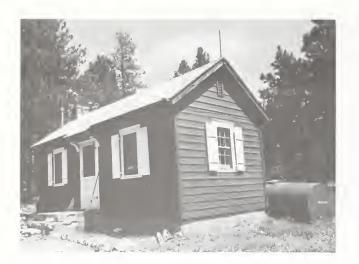
Figure 106. The Dutch Joe lookout cabin, Apache-Sitgreaves National Forests.

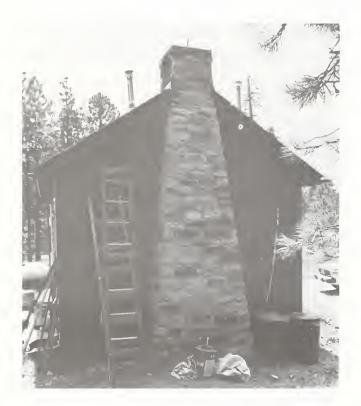
Figure 107. A well-made chimney graces this end of the Dutch Joe lookout cabin.

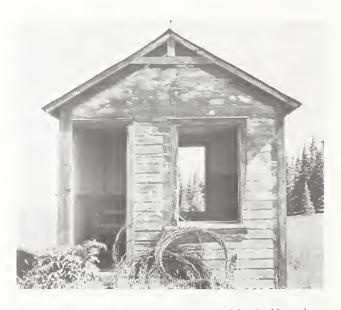
Figure 108. Canjilon lookout cabin built circa 1909 on the Carson National Forest.

The lookout's cabin remains at the site. It is wooden framed and measures 10 feet by 14 feet. The exterior was painted green; interior walls are painted half green and half white (Figures 108 and 109). The bunk bed, constructed of spruce poles, remains in the cabin. The interior and exterior walls are built of 1 inch by 6 inch rough lumber. There is a pitched tin roof topped with a bar which may have provided lightening protection. The cabin's foundation is cement.

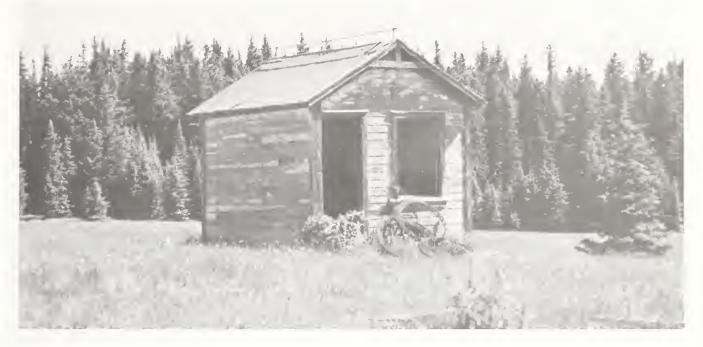
Figure 109. Canjilon lookout house, Carson National Forest. This cabin is the oldest surviving structure in the Southwestern Region related to forest fire detection.

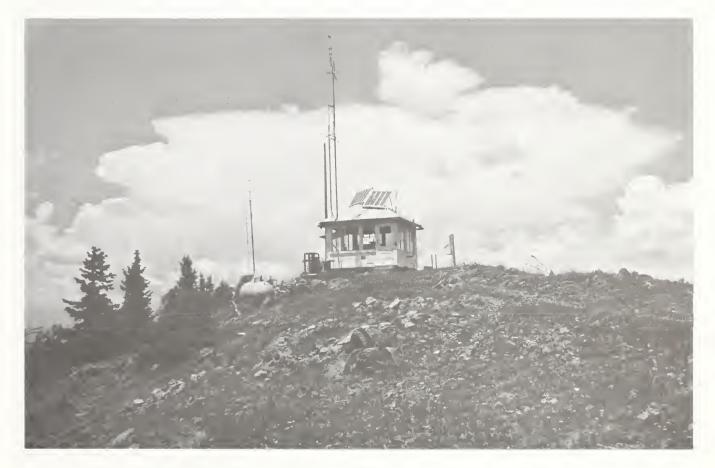
Figure 110. Picuris lookout commands a wide view from its windswept site on the Carson.

This L-4 type lookout house was constructed on Penasco Ranger District between 1928 and 1932 (Figures 110 and 111). The house is a wood-frame construction, measures 12 feet square and rests on a stone and cement foundation. The roof has wood shingles and solar panels were installed in 1982 and 1984. The interior ceiling was replaced and new windows were installed in 1981. Considerable structural changes have been made: the lookout house does not retain its original integrity of design, construction, workmanship and materials. National Register eligibility is not recommended.

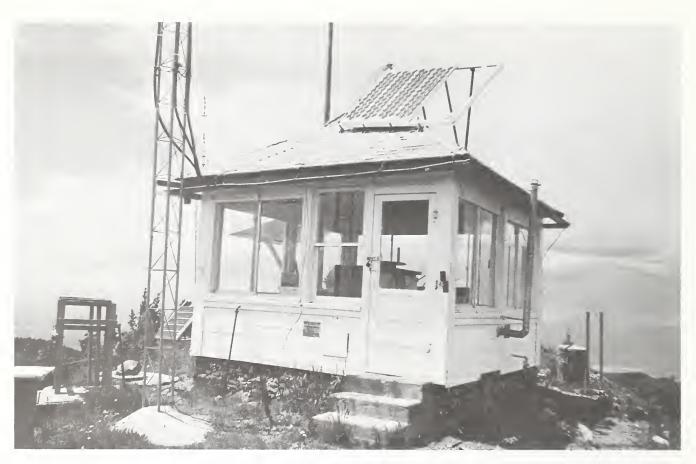
Figure 111. Picuris lookout house (type L-4) on Carson National Forest equipped with solar power.

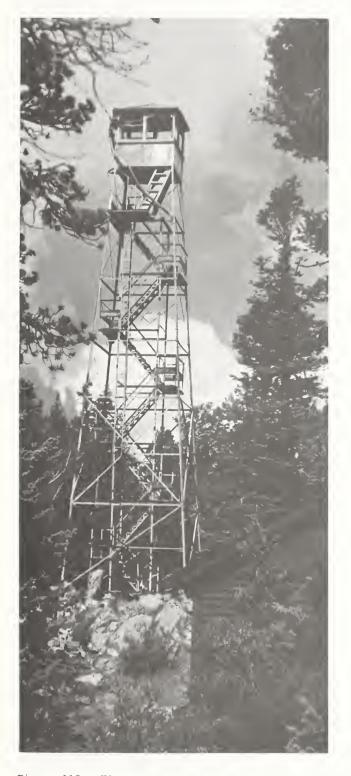
Located on the El Rito Ranger District (Figures 112 and 113), this 50 foot tall steel tower has a steel cab 7 feet square and was erected in 1923. The type is an Aermotor LL-25, one of two surviving lookouts of this type the in Southwestern Region (the other being the Deer Springs lookout on the Apache-Sitgreaves National lookout Forest). The has undergone some modification at unknown dates. The original ladder was replaced by stairs, the interior has been rebuilt with new windows, ceiling and trap door. This lookout has recently been vandalized and is no longer used. The modifications have been extensive and the original integrity of design, construction, workmanship and materials has been lost. Documentation on the cabin, built

Figure 112. Kiowa lookout, an Aermotor LL-25, on the Carson National Forest.

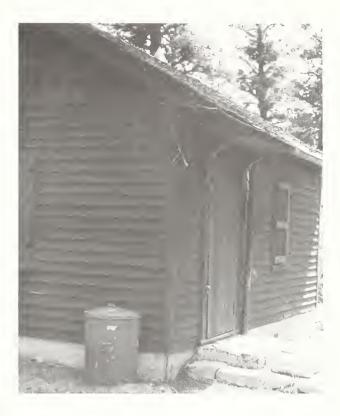
in 1935, was insufficient to properly assess the current condition and extent of modifications. Therefore, there is not adequate data at this time to make a recommendation regarding National Register eligibility.

Figure 113. The Kiowa lookout cabin, Carson National Forest.

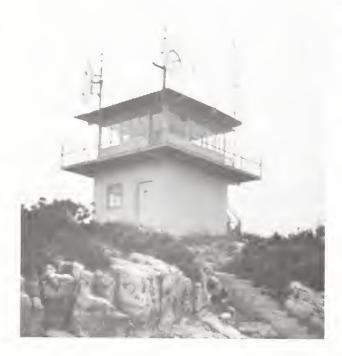
is a Standard Plan CL-100 to CL-106 series (Figure 114). Its 14 feet square steel cab rests on a concrete block base 10 feet high. It was erected by the Forest Service in 1963, replacing a L-4 lookout house erected in 1927. The lookout is less than 50 years old, does not represent an exceptional type and is not recommended for National Register eligibility.

Figure 114. Capilla lookout, a CL-100 type built in 1963 on the Cibola National Forest.
